CHARACTER OF CHANNEL PLANFORM CHANGE AND MEANDER DEVELOPMENT: LUANGWA RIVER, ZAMBIA

DAVID GILVEAR^{1*}, SANDRA WINTERBOTTOM¹ AND HENRY SICHINGABULA²

ABSTRACT

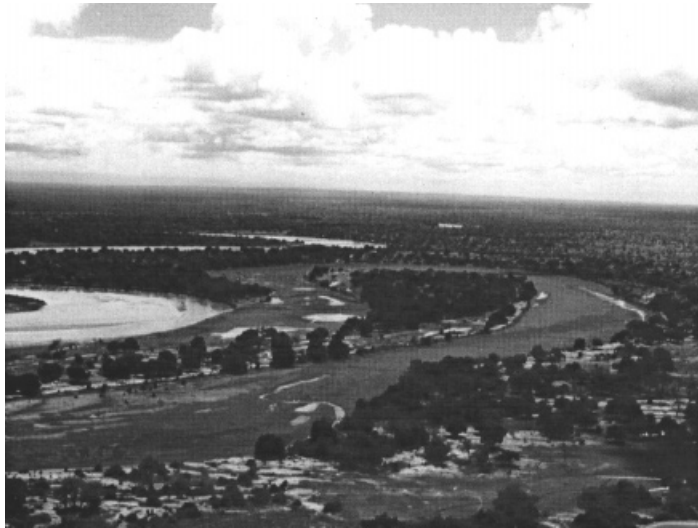
Figure 5. An oblique aerial photograph of bend 8 showing the present-day active channel and the infilled and terrestrialized course of the former river (active in 1956)

Reach B. Reach B is characterized by a single-thread meandering channel. To the north of the reach it currently exhibits a low sinuosity meandering river but tortuous asymmetric meanders are apparent in the south. In this lower section the floodplain is a series of old infilled meanders and cutoff lagoons of recent origin which show that the river in the recent past was highly tortuous in planform (Figures 4 and 5).

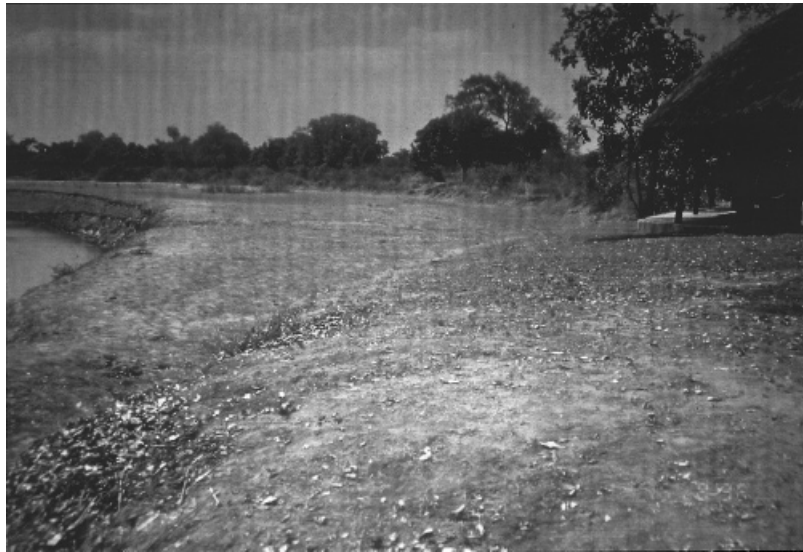
Figure 6. Photograph showing a concave bank bench at bend 9 taken from Nsefu safari camp. The safari lodge bar can be seen on the right and the concave bank bench to the middle left of the picture below the original outer bank

instances of bend contractions leading to the formation of concave bank benches. Four pronounced concave bank benches within the study reach are apparent (e.g. Figure 6). Bend contraction is reflected in marked differences in bankfull channel width between successive dates; contraction of channel widths by up to 50 per cent was observed, although overall between 1957 and 1988 channel widths increased by 20 per cent.
